TAILINGS DAMS RISK OF DANGEROUS OCCURRENCES

Lessons learnt from practical experiences

Bulletin 121

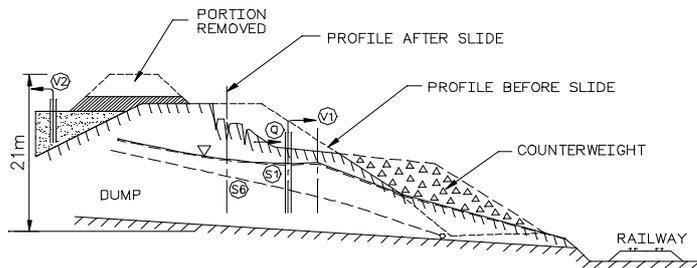
Figure 12. Section of starter dam formed by an existing dump.

- S1 = PHREATIC LINE 1 DAY BEFORE SLIDE
- S6 = PHREATIC LINE 6 DAYS BEFORE SLIDE
- Q = WATER ESCAPING FROM HIDDEN COARSE LAYER
- V1 = WELLPOINTS FOR REMOVAL OF POREWATER FROM DAM BODY
- V2 = WELLPOINTS FOR REMOVAL OF POREWATER FROM SEDIMENTED TAILINGS

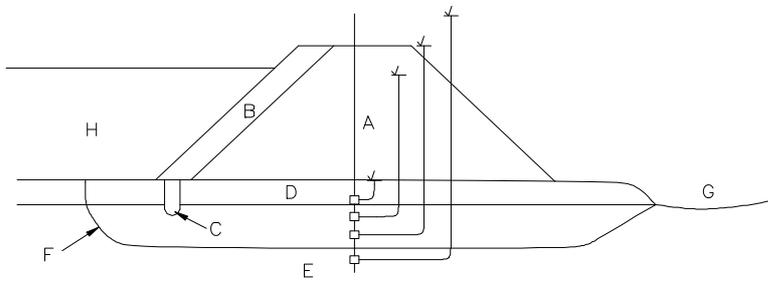
Figure 13. Section of Aznalcóllar Tailings Dam.

- A WASTE ROCKFILL.
- B EARTHFILL.
- C SLURRY TRENCH CUT-OFF.
- D ALLUVIAL SAND AND GRAVEL ABOUT 4m THICK.
- E BLUE MARL 60m THICK. $k = 10^{-11}$ to 10^{-12} m/s.
- F SLIP SURFACE. $c' = 0$, $\phi' = 16^\circ$
- G RIVER
- H TAILINGS. $\gamma = 28 \text{ kN/m}^3$

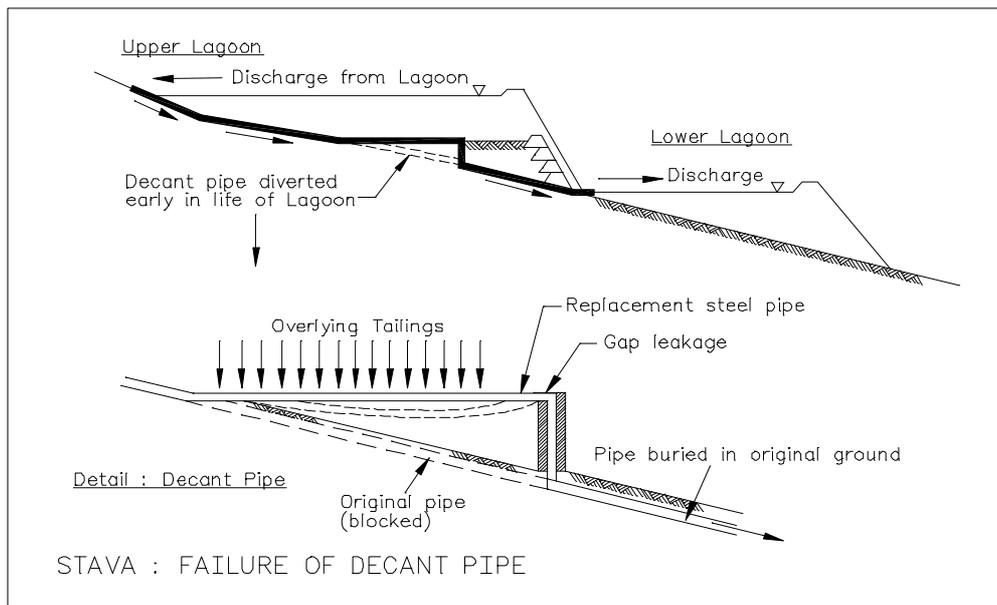
Figure 16. Failure of the decant pipe at Stava.
