TAILINGS DAMS RISK OF DANGEROUS OCCURRENCES

Lessons learnt from practical experiences

Bulletin 121

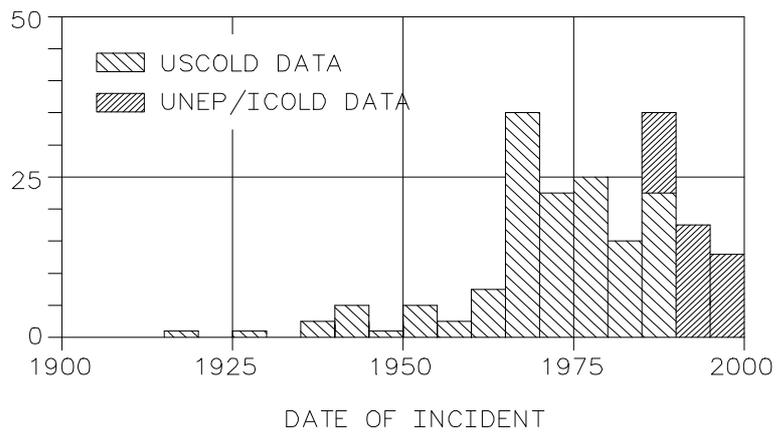
Figure 2. Tailings dam incident history summary: number of incidents per 5 year period.

the UNEP/ICOLD collected data. It should be noted that all the figures showing tailings dam data are plotted with the number of incidents as the dependent variable. Fig.2 shows an increase of incidents starting in the mid-1960s. This increase is most likely due to the larger number of tailings dams constructed after 1960 combined with the more thorough documentation of tailings dam operation. The USCOLD and UNEP surveys have provided a total of 211 incidents for comparison. Clearly all incidents have not been reported, and this collected number form a subset of the actual number of tailings dam incident that have occurred from the early 1900s to 1996. The following discussion of results is presented in terms of the number of incidents, rather than downstream effects or cost of repair or remediation. A comparison of the number of incidents with tailings dam height is given by Fig.3, where it will be seen that about 57% of the incidents occurred in dams less than 20 m high. A comparison of actual dam failures with dam height is given by Fig.4 which shows that approximately 63% of the failures occurred in dams lower than 20 m.

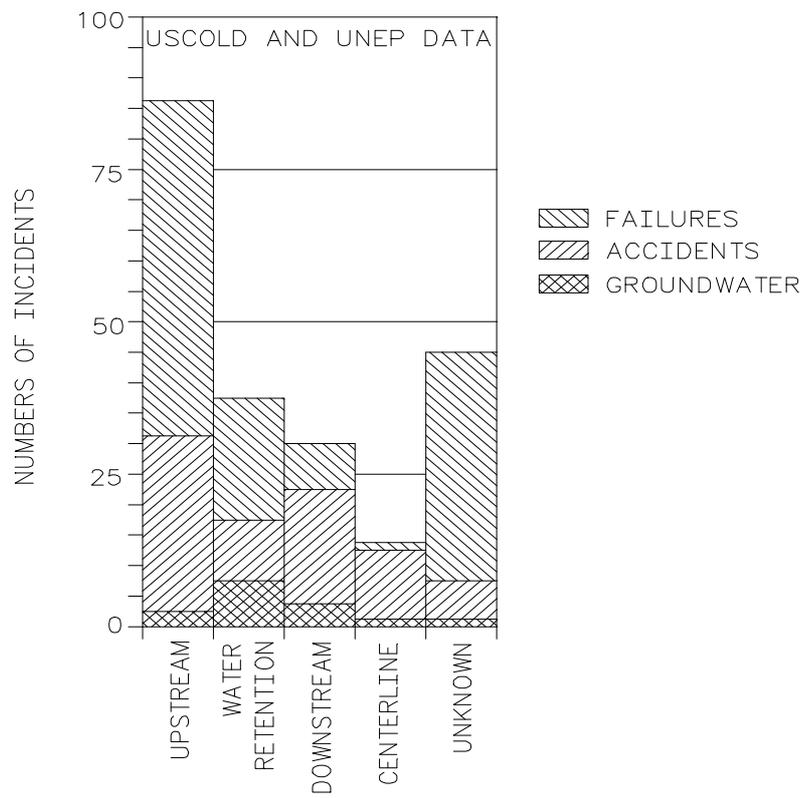
Figure 6. Tailings dam type comparison.

As can well be imagined, the type of construction of the tailings dam must play a part in its behaviour. One of the earliest and the most common types of construction is by the upstream method: tailings dams constructed with tailings by the upstream method have been documented in South Africa in the early 1900s (*types of construction have been described in Bulletin 106*): traditional embankment dams when used to retain impoundments, are referred to as water retaining type dams. Because of the risk of failure of dams built by the upstream method, particularly when subject to earthquake shaking, the downstream method was developed; and there is a centreline method that is a compromise between the former two methods. As Fig.6 shows clearly, there are many more incidents with dams built by the upstream method than with other types, but also there are many more of these type of dam than of other types amongst the examples that we are considering.

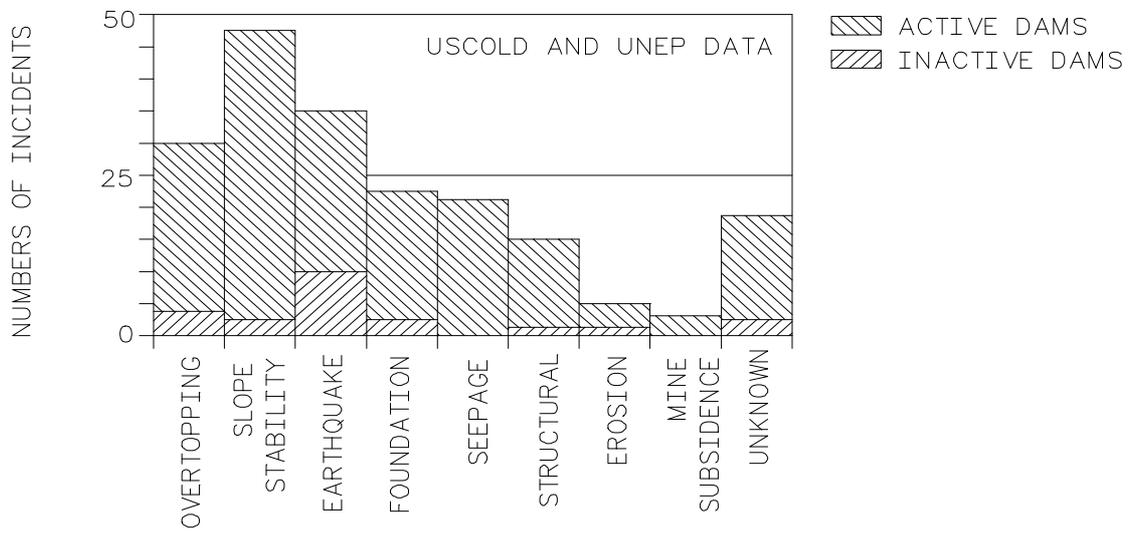
Figure 7. Tailings dam incident cause comparison with dam status.

When an impoundment has become completely filled, or when tailings production ceases, the tailings dam and its retained impoundment is described as inactive. This does not make them immune to accidents or failures and, as shown by Fig.7, relatively few incidents were associated with inactive dams. A cause of failure of inactive dams is increase of pool water level, bringing the pool closer to the dam crest thereby bringing the phreatic surface to the downstream slope, leading to eventual slips and overtopping. A method to avoid the overtopping of closed impoundments consists of building a subsidiary dyke some distance back from the crest of the tailings dam to permit the level of the pond water to rise during an emergency without risking the main dam. The section of such a dam in Germany is shown by Fig.5.

An indication of the causes of incidents, for active and inactive tailings dams are given by Fig.7, where it will be seen that the leading cause of incidents for active dams are slope instability, overtopping and earthquake. For inactive dams, the leading causes of incidents are overtopping and earthquake. Fig.8 similarly shows incident cause for active dams, separating failures from accidents. Finally, Fig.9 shows the total incidents with their cause separated by tailings dam type. This figure also indicates that the leading causes for incidents are slope instability, earthquake and overtopping; particularly so for dams constructed by the upstream method. The incidents must be reviewed in terms of the number of particular dam types in operation. The upstream method is the oldest and most commonly used method of tailings dam construction. This method, as pointed out by Mittal and Morgenstern (1977), was used at sites prior to the use of foundation investigation and slope stability

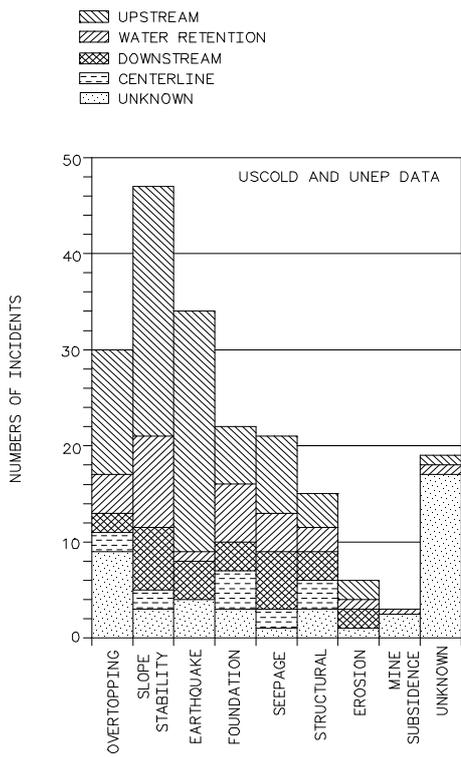
Figure 9. Tailings dam incident cause comparison with dam type.

The incident survey results show that there is no overriding cause or mechanism for all tailings dam incidents, but it is intended that readers may find examples close to cases under their control, and benefit from the experiences recorded here. As shown by Fig.9, incidents are due to a number of factors including overtopping, static and seismic instability, seepage and internal erosion, external erosion, structural and foundation conditions. In addition, no type of tailings dam or operational condition is particularly immune from incidents. Although the majority of tailings dam incidents are associated with active tailings impoundments, a range of types of incidents have been recorded at inactive impoundments.

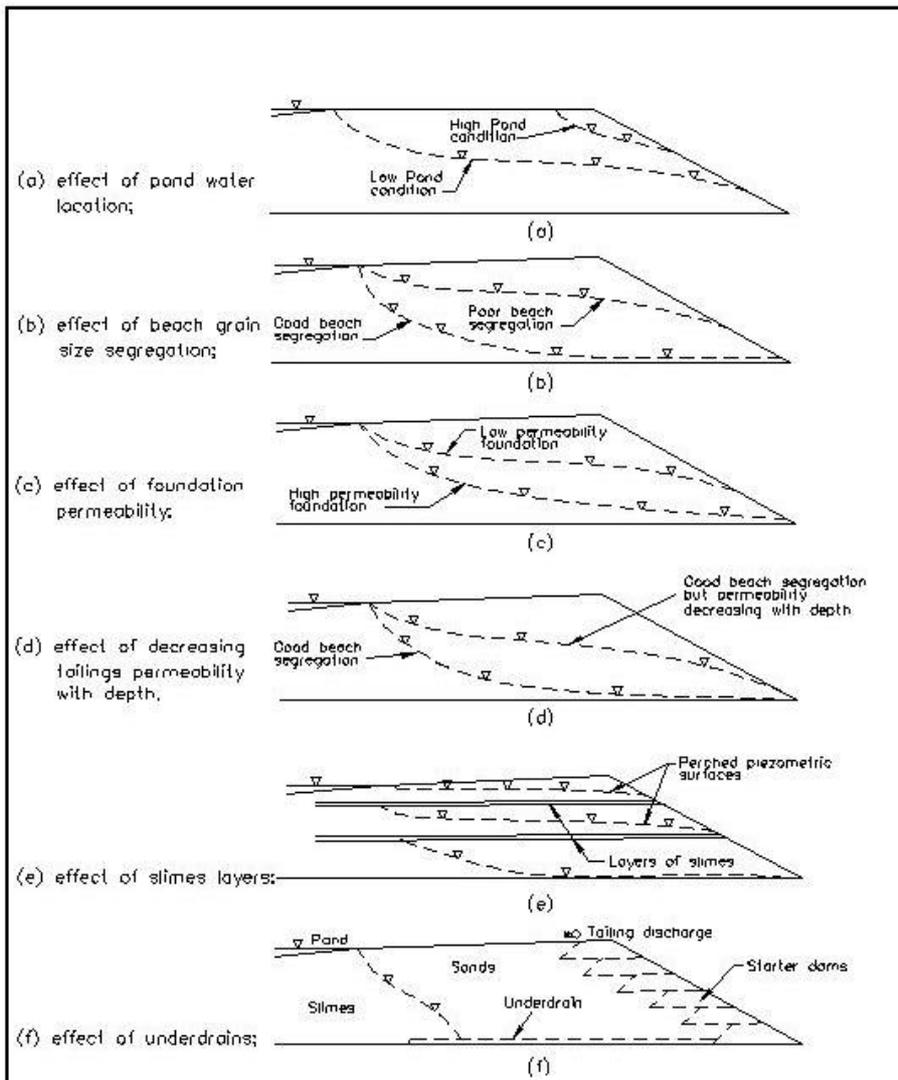
With a dam being built by the upstream method, the coarsest particles settle out nearest to the crest, with reduction of particles sizing with advancement down the gently sloping beach until only the finest particles are left to be carried into the pond where they settle. While the surface of the water in the pond is visible, with distance moving downstream towards the dam crest, the level of the water within the tailings, referred to as the phreatic surface, falls as it approached the downstream slope where it can drain out or evaporate. In some early dams, built without drains, the positions for the phreatic surfaces under various conditions, are shown by Fig.10. Variations of placement, particle sizes etc., cause the body of an impoundment to be extremely anisotropic with regard to permeability. This results in equi-potential lines that are far from vertical, which can cause an incorrect measurement of the position of the phreatic surface by open standpipes that have long intake filters. Also layers of materials of low permeability can produce perched phreatic surfaces, as indicated by Fig 11(e). In fact it is essential for the stability of the dam that the phreatic surface is kept well back from the downstream slope. When it is allowed to move downstream by allowing the pond to move too close to the dam crest, local small rotational slips will occur where the phreatic surface meets the downstream slope.

Figure 10. Factors influencing the position of the phreatic surface in dams built by the upstream method. Shows effect of lack of drainage and layers of low permeability producing perched water surfaces. (After Fell et al 1992)

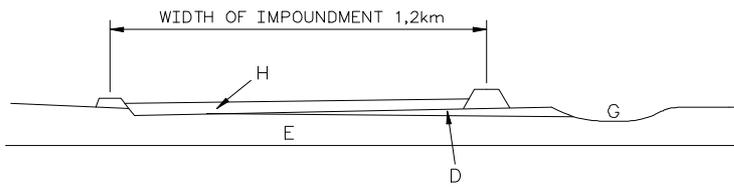
Figure 13. Section of Aznalcóllar Tailings Dam.

- A WASTE ROCKFILL.
- B EARTHFILL.
- C SLURRY TRENCH CUT-OFF.
- D ALLUVIAL SAND AND GRAVEL ABOUT 4m THICK.
- E BLUE MARL 60m THICK. $k = 10^{-11}$ to 10^{-12} m/s.
- F SLIP SURFACE. $c' = 0$, $\phi' = 16^\circ$
- G RIVER
- H TAILINGS. $\gamma = 28 \text{ kN/m}^3$

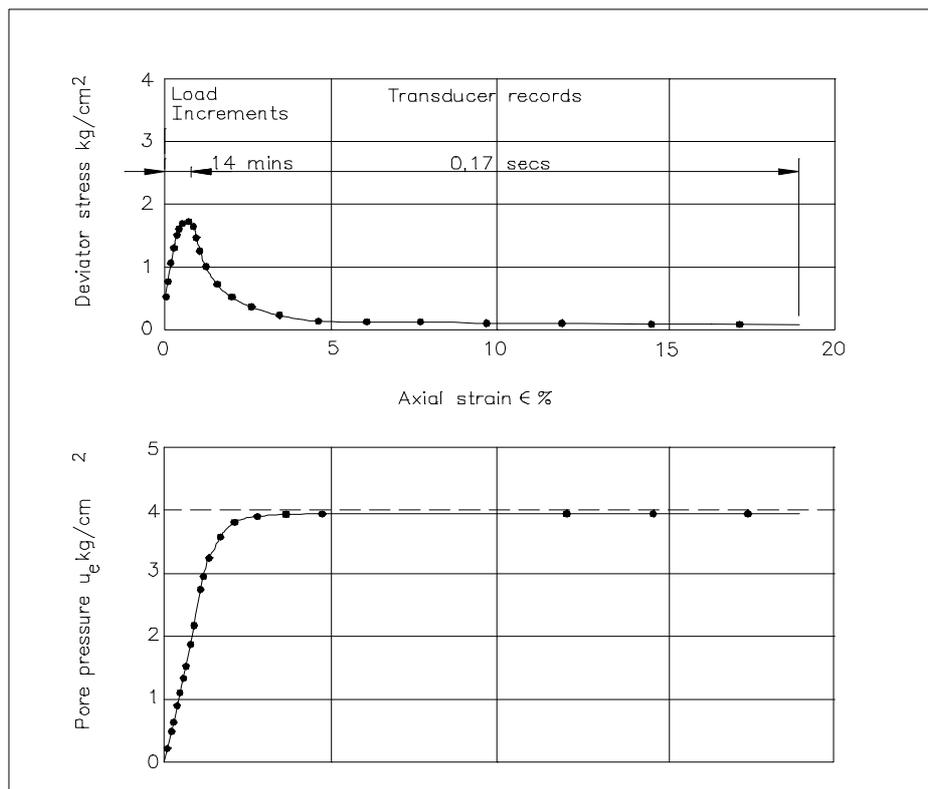
Very loose, normally consolidated saturated material as are tailings in an impoundment, exhibit a peak strength higher than the residual strength at greater strains, when tested in apparatus using strain control. This effect is shown more vividly in stress controlled tests, i.e. tests in which the shearing force is applied by weights: an example given by Castro (1969) is shown by Fig.17. The tests were made on a fine uniform sand with a D_{10} size of 0.1 mm at a relative density of 29% using a confining pressure of 400 kN/m². Load was applied in small increments and peak deviator stress was reached in 14 minutes at a strain of 1%, during which time the pore pressure increased to half the confining pressure. But once the peak strength had been reached the strain increased to 19% in 0.17 seconds. The pore pressure climbed to almost the value of the confining pressure and as a consequence the strength fell to almost nothing. This is the mechanism of a flow slide.

Figure 17. Stress-strain curve for stress controlled consolidated undrained test on saturated loose sand.
